ARPA'S GEOLOGICAL MONITORING NETWORK: THE USE OF GROUND BASED InSAR

Luca Dei Cas – Centro di Monitoraggio Geologico ARPA Lombardia

GALLIVAGGIO LANDSLIDE: AREA LOCATION

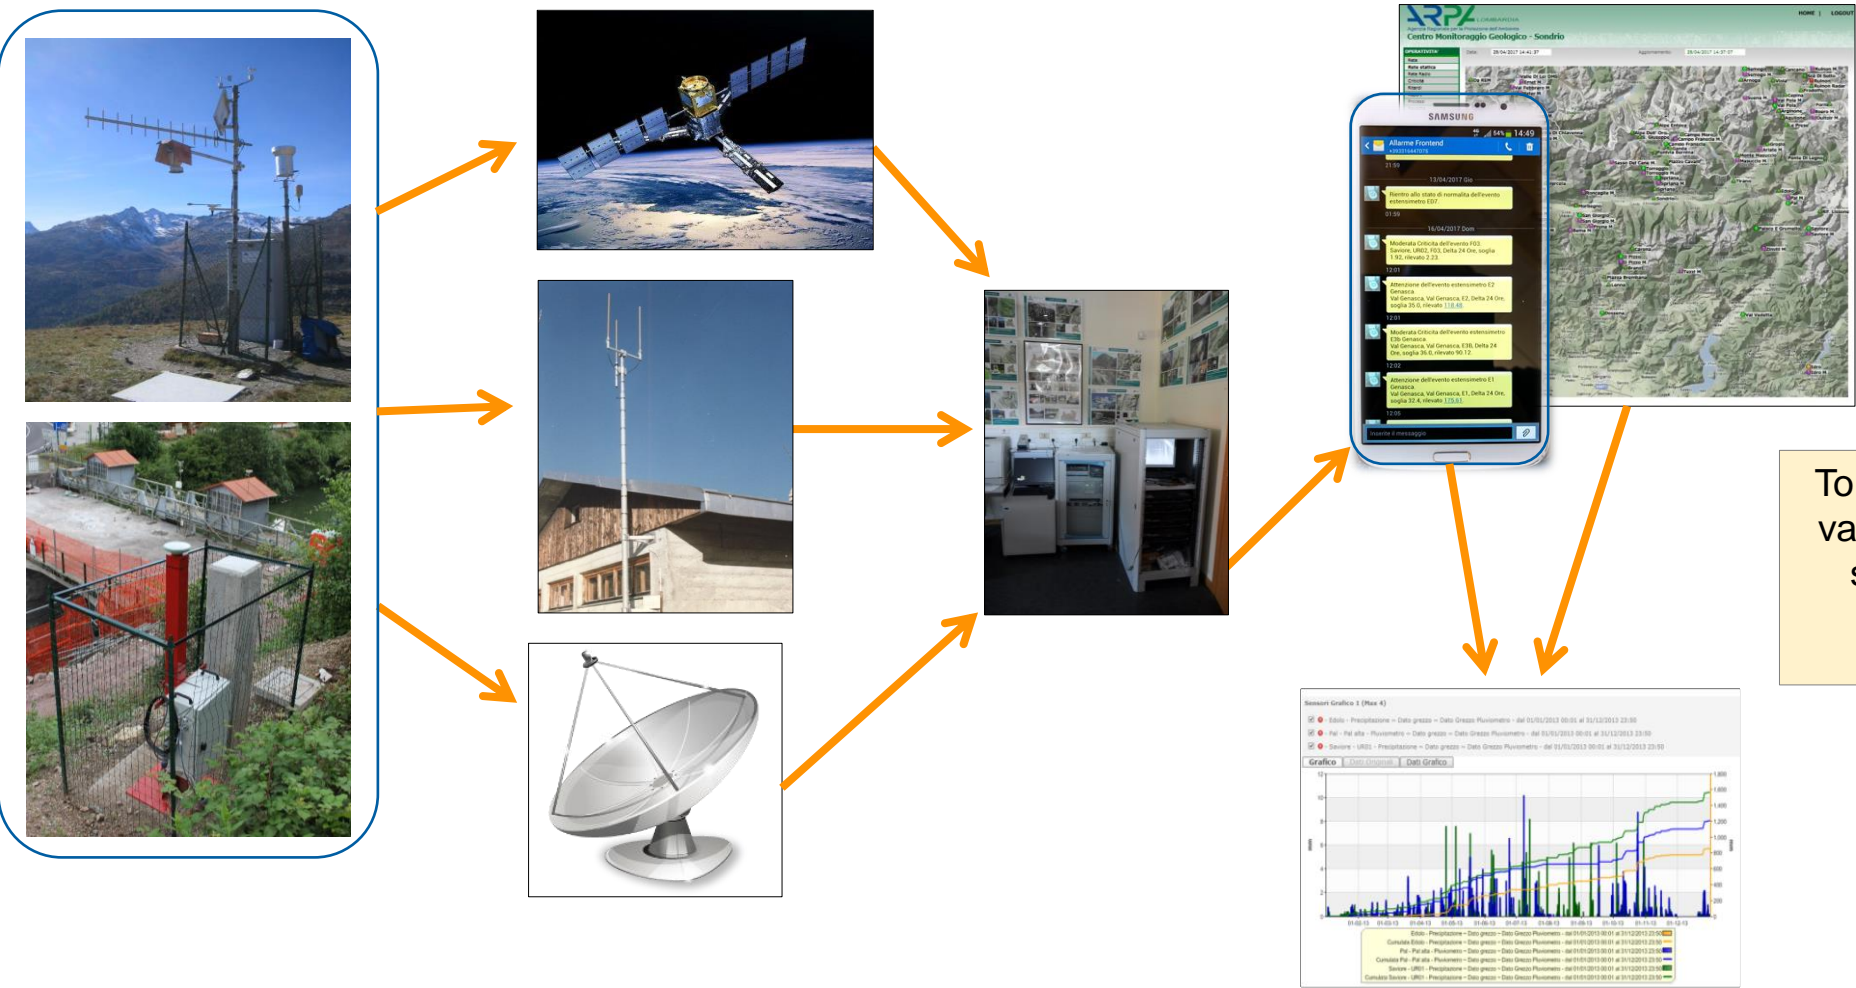
DOUBLE (REDUNTANT) TRASMISSION

To guarantee the transmission of data values from landslides even in critical situations, it's important to have a transmission redundant system

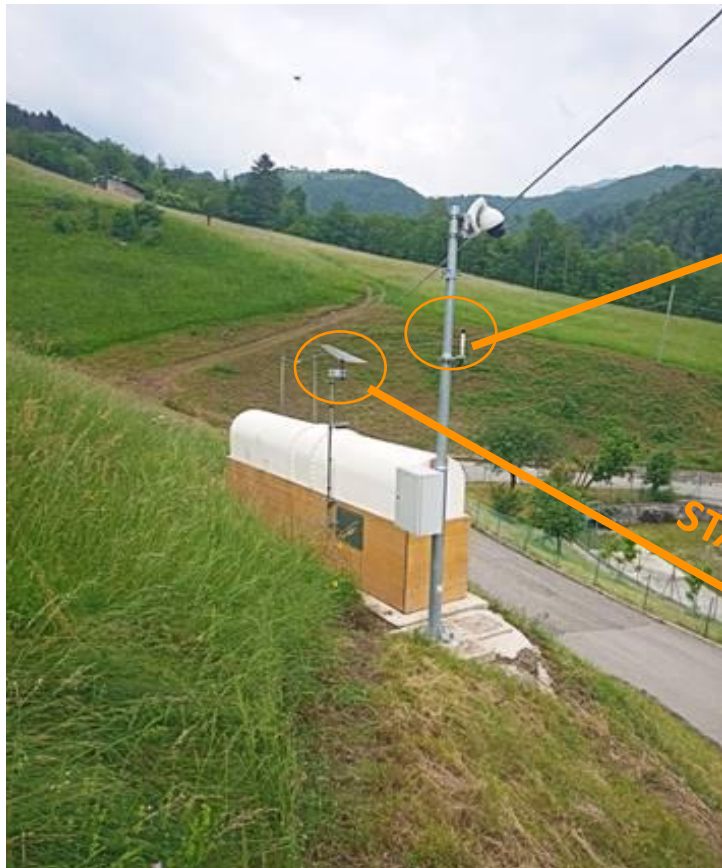
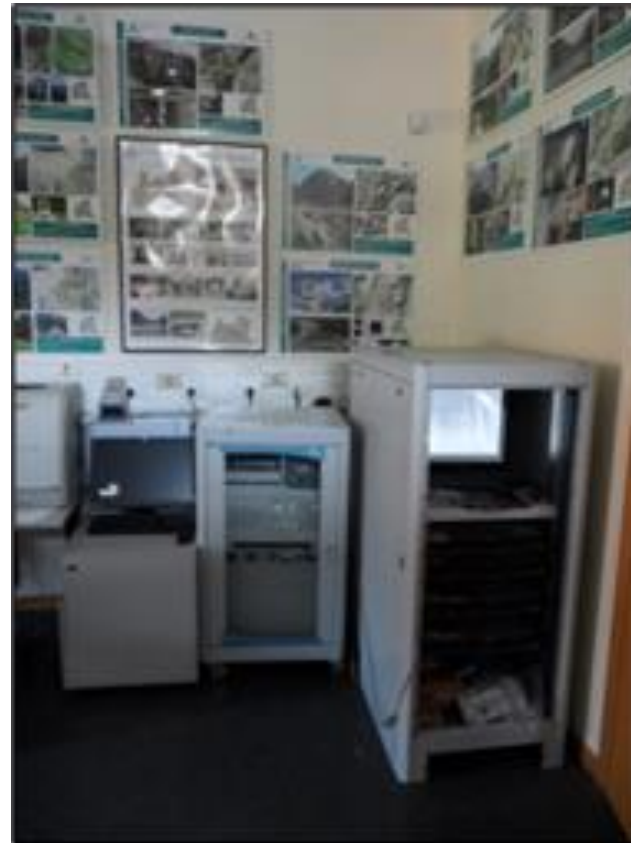
GROUND SAR RADAR: REDUNDANT TRANSMISSION

GPRS

STARLINK

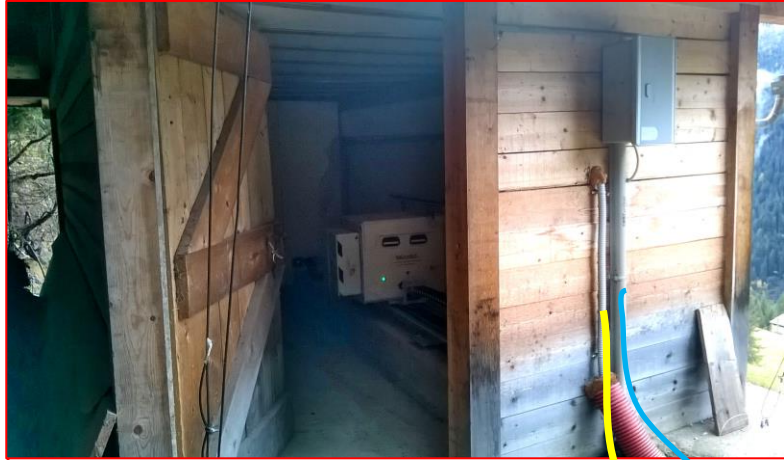
AREAS MONITORED BY GROUND SAR RADAR FOR EARLY WARNING : REDUNTANT ENERGY POWER

Power line connection

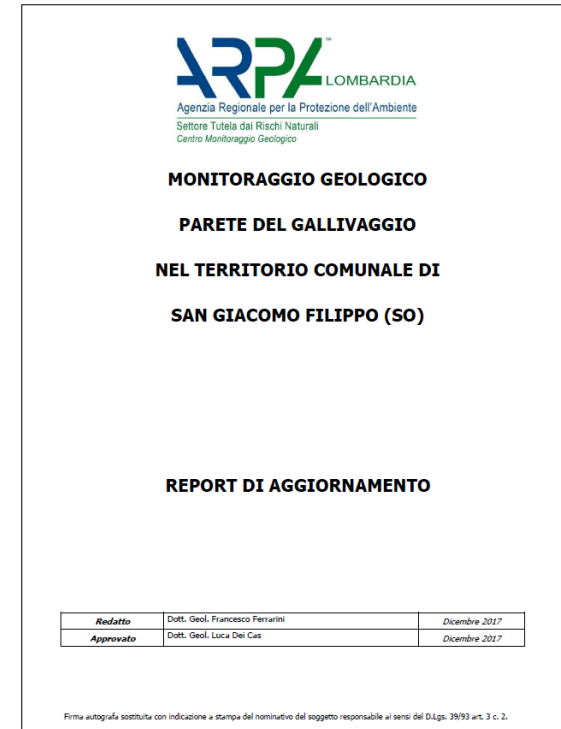
During the Autumn 2017 the data analysis values acquired, enabled us to notify the Lombardy Region Civil Protection of a **dangerous acceleration** of movement in about 460 m² of the rock area (5-6000 mc).

In February 2018, we sent another notification in which we informed the Civil Protection about the acceleration showed a doubling of the values compare to the previous ones in Autumn.
